STEAM TURBINES IN COMBINED CYCLE : RELIABILITY & PERFORMANCE IMPROVEMENT SOLUTIONS IAGT 2017

David Archambeault*†

EthosEnergy

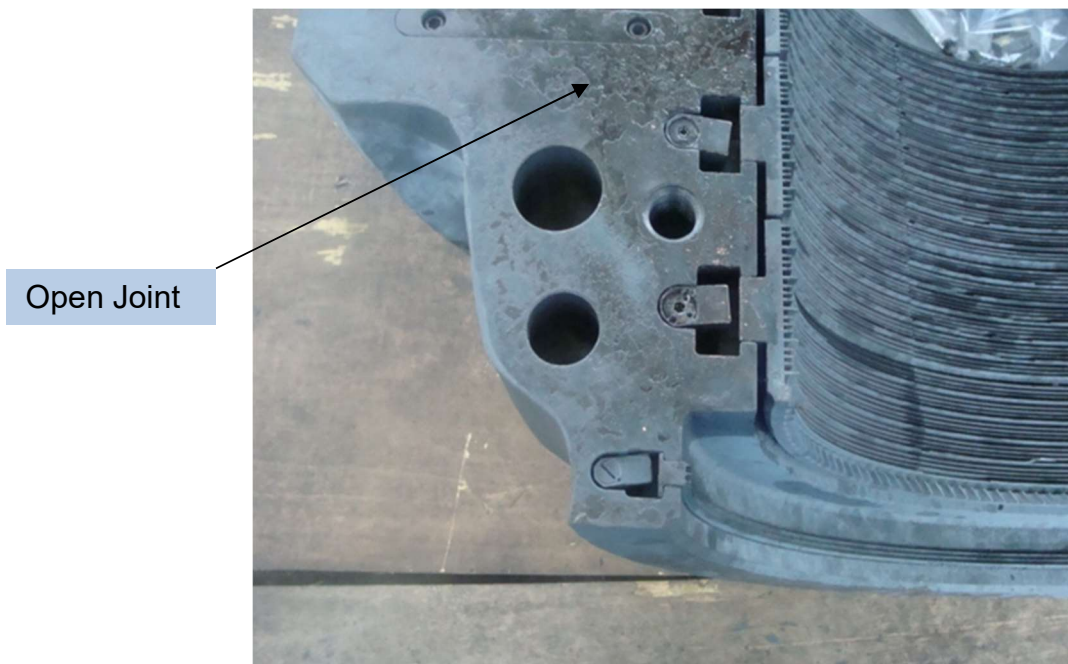
Steam leakage at the N2 packing casing horizontal joint is shown in Figure 2.

Figure 2: N2 Packing Casing Horizontal Joint Leakage

Loose nuts are observed upon disassembly, and on occasion the studs difficult to remove resulting in the need for machining out the studs. Once the N2 shell is split, evidence of steam leakage is observed across the horizontal joint area as shown in Figure 2. This leakage decreases efficiency of the HP section and causes steam cutting of the studs at the joint area. Leakage also impacts the ability of retractable seals to function properly as the pressure drop across the retractable seal is altered, decreasing segment closure forces – effectively leaving retractable seals in their open configuration during full speed full load operation.

Analysis performed on this area indicates high temperature creep damage of the stud/casing threads occurs, combined with stud preload relaxation. The majority of the creep damage of the OEM 422 bolting material occurs within the first year of operation. Over time when operating at high temperatures, preload relaxation prevents the ability of the joint to remain sealed against further leakage. Furthermore, for distorted joints, a large portion of bolt preload is needed to close the joint at reassembly. Little to no force remains to compress the joint and seal it in operation resulting in further leakage of high temperature steam into the bolt holes, further exacerbating the issue of casing thread creep damage. This has resulted in tertiary creep damage of the casing threads, or thread failure.

OEM recommendations and solution involve changing the bolt material, however, without addressing the lower half casing thread issue.

Another solution option is to change not only the stud material, but also to utilize a double-nut configuration as shown in Figure 3. This solution eliminates the need to use the casing material for threading altogether. This approach is especially beneficial for units that were once designated as base-load but have since increased in cycling duty as the thermal cycling resulting from starts/stops.

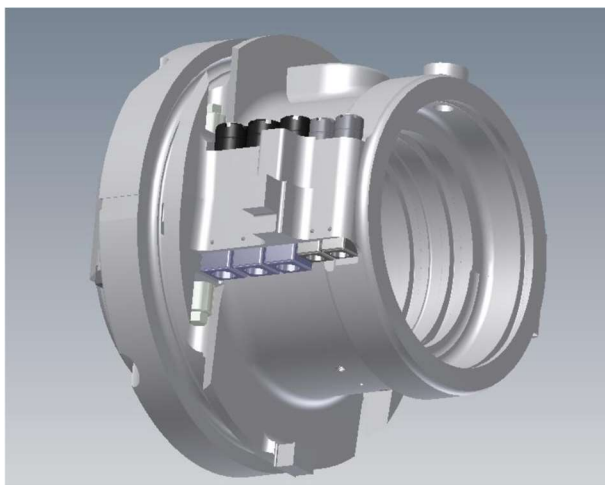
Figure 3: Redesigned N2 Packing Box with Double-Nut Configuration

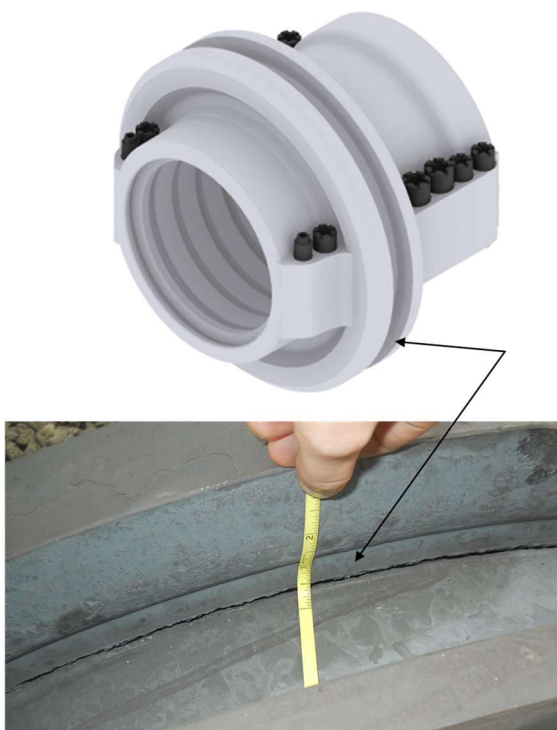
Ledge cracking as shown in Figure 4 is observed at the main fit to the turbine HP shell.

Figure 4: N2 Packing Casing Ledge Cracks

These cracks occur in the main fit fillet radius on the active face (HP end) both upper and lower halves. Cracks initiate in this area due to low cycle fatigue and creep rupture damage due to the high stress concentration (small radii) combined with high temperature operation of approximately 566 C (1050F).

Solutions available for the N2 ledge cracking issue may be a repair by machining of a larger radii at the shell fit area which removes the crack in the process (shown in Figure 5), or replacement of the entire N2 packing casing altogether (shown in Figure 6).

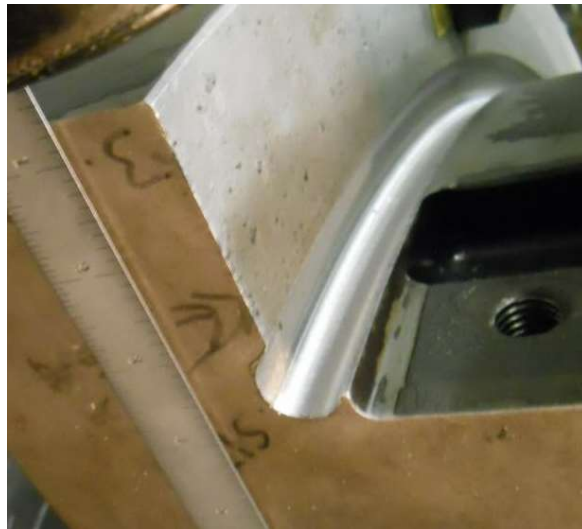
Figure 5: Machining of N2 Main Fit Radii

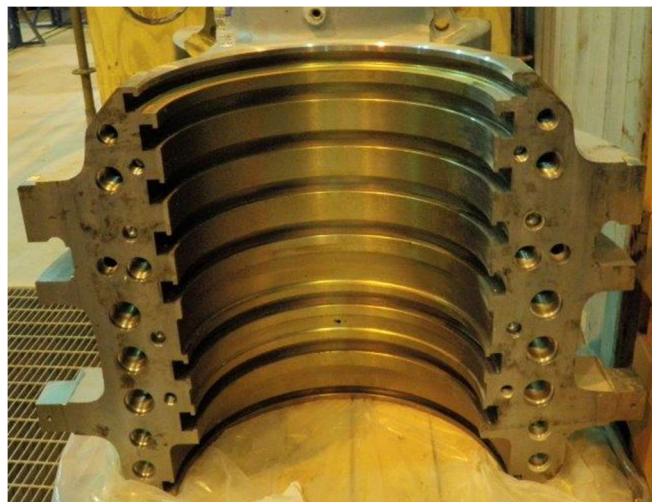
Figure 6: New N2 Packing Casing

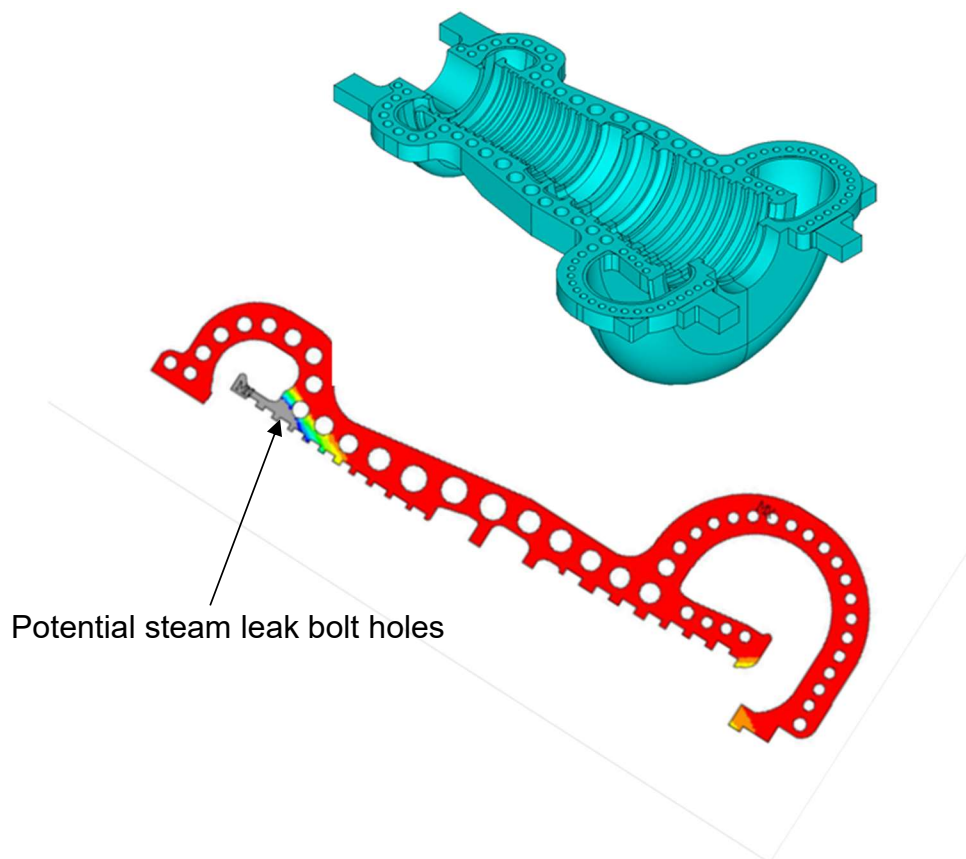
Similar in nature to the N2 packing casing leakage is the HP shell (shown in Figure 7) leakage. As in the case of the N2 box, the HP shell also exhibits leakage area as shown in Figure 8.

Figure 8: HP Shell Model and Horizontal Joint Leakage Path

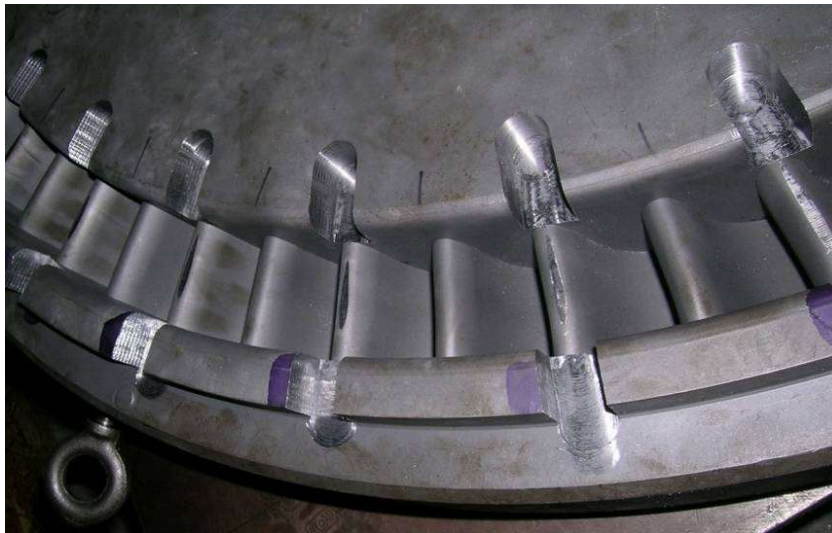
Distortion of diaphragms in the way of creep deformation occurs in the hot stages of the HP and IP sections. This is typically observed upon opening inspection as diaphragm drop checks are performed. In addition to the drop checks, axial rubs with the rotor are observed as are fractured trail edges of the units. Developed solutions for this creep distortion include the installation of stiffeners at the stationary nozzle lead edge sections as shown in Figure 9.

Figure 9: Preparation For Diaphragm Stiffener Welding

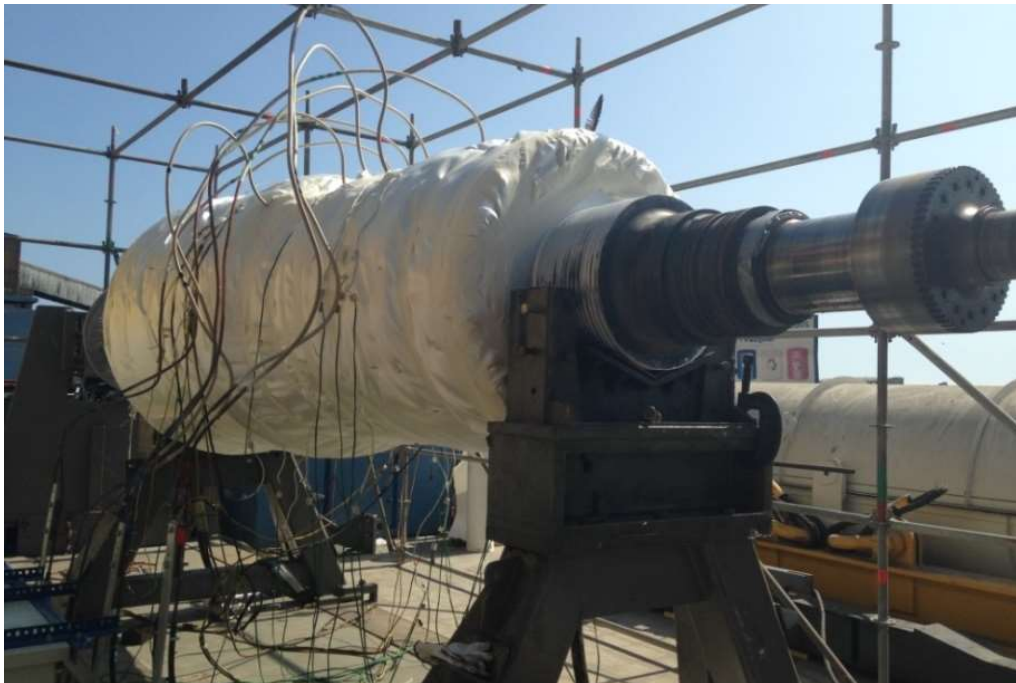
Bowing of the HP/IP rotor (shown in Figure 10) is seen across the fleet, due in part to rubs during startup / shutdown, distortion of the casing, water induction events, FOD, improper techniques relating to slow roll, rotor thermal stability / growth problems. Residual stresses and creep/plastic deformation can result, causing a bow to remain in the rotor.

Figure 10: HP / IP Rotor Preparing for Straitening Process

Figure 10 shows an alternative option available to owners/operators is a proprietary horizontal straightening method.

This method was developed many years ago and has been used successfully as a long term solution. This process involves first understanding some of the underlying material issues for the specific rotor through extensive initial NDE techniques. This inspection process yields a greater understanding of potential residual stresses in the rotor, their location and relative magnitude. Following the NDE, an FEA is performed for each rotor to support a custom straightening process. Figure 11 shows typical results achieved during this process.

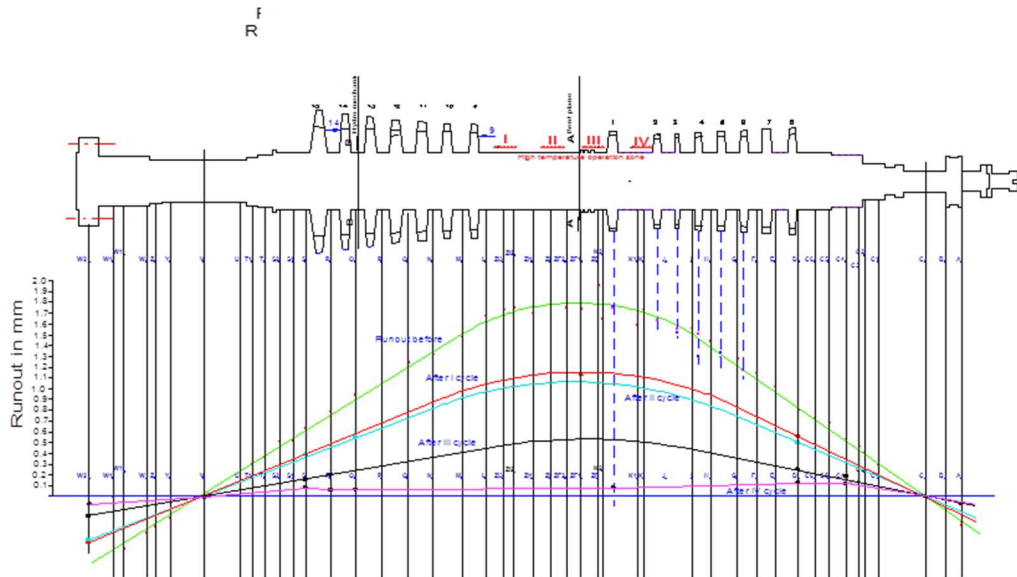
Figure 11: Before and After TIR

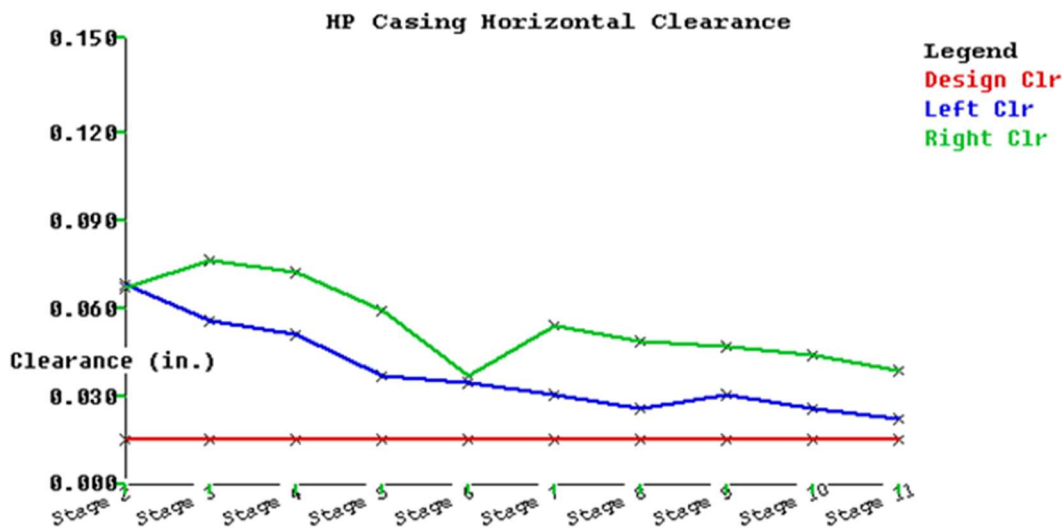
Results from a steampath audit are shown in Figure 12 for the HP casing horizontal clearances and Figure 13 for axial clearances.

Figure 12: HP Casing Horizontal Clearance

For the HP Conventional Packing:

- Avg. horizontal wear = 35 mils
- Avg. top wear = 15 mils
- Avg. bottom wear = 60 mils

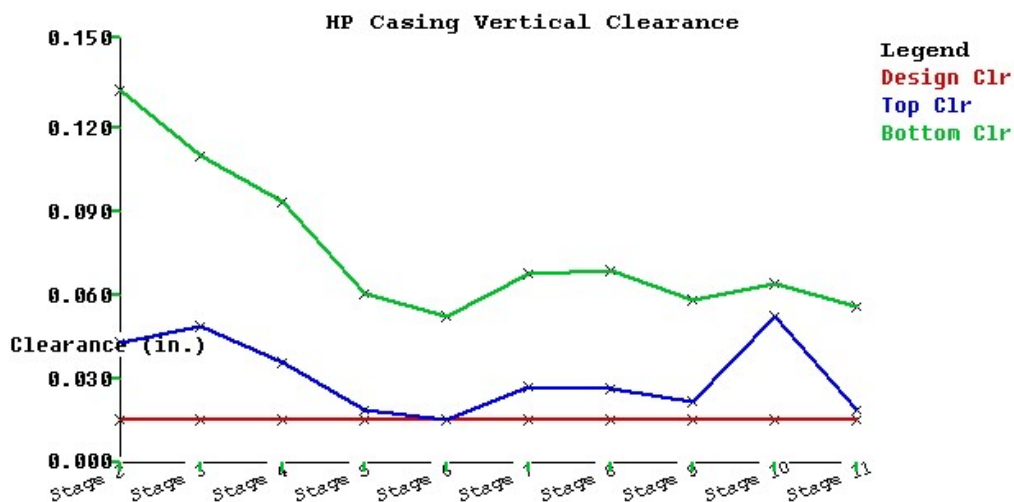
Figure 13: HP Casing Vertical Clearance

IP Conventional Packing:

- Avg. horizontal wear = 15 mils
- Avg. top wear = 20 mils
- Avg. bottom wear = 65 mils

Wear on the bottom segments is significantly greater than top and sides. Similar wear pattern is evident also on rotating on tip seals.

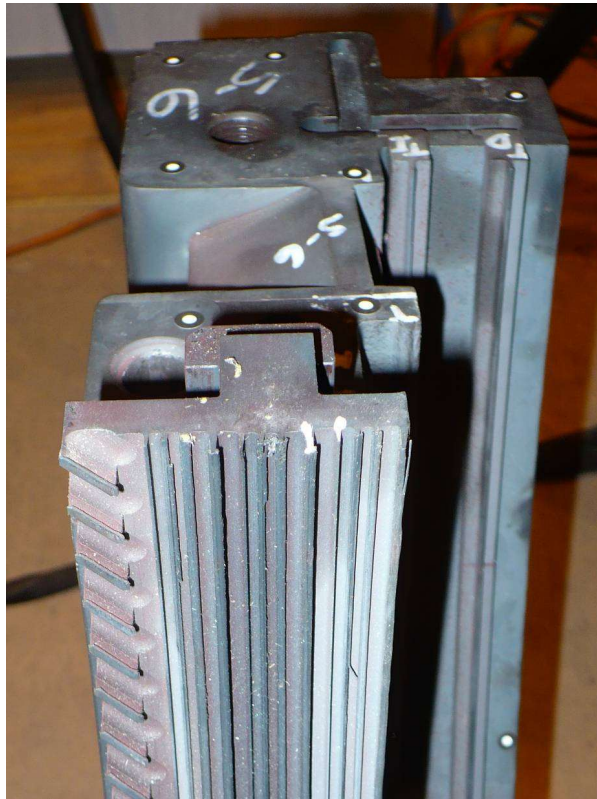
Also noted are heavy rubs of the lower half horizontal joint. Although clearances are generally larger on the bottom, the wear is substantial at all locations, see Figure 14.

Figure 14: Heavy Seal Rub

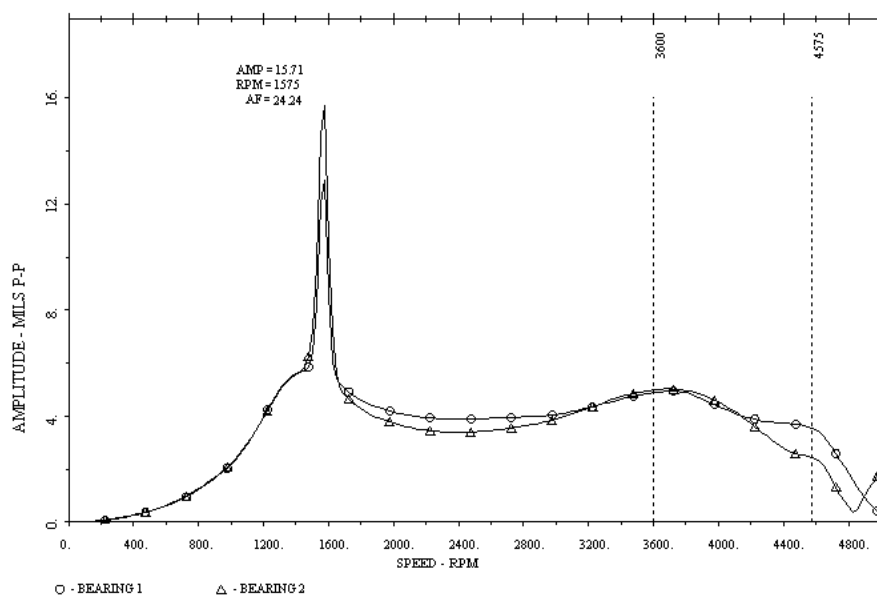
Resulting from these seal rubs and a combination of other factors is rotor vibration. The HP/IP rotor in the D-11 is very flexible and is sensitive to midspan rubs. Further analysis indicates an amplification factor of over 24 as shown in Figure 15. Rotor trip on high vibration is 7.5 mils peak to peak, with a max displacement at seal location of .156 mils peak to peak as shown in Figure 16. Therefore, with a radial displacement of 78 mils, subtracting the operating clearance any casing distortion reduces the effective seal clearance.

Figure 15: HP/IP Rotordynamic Evaluation

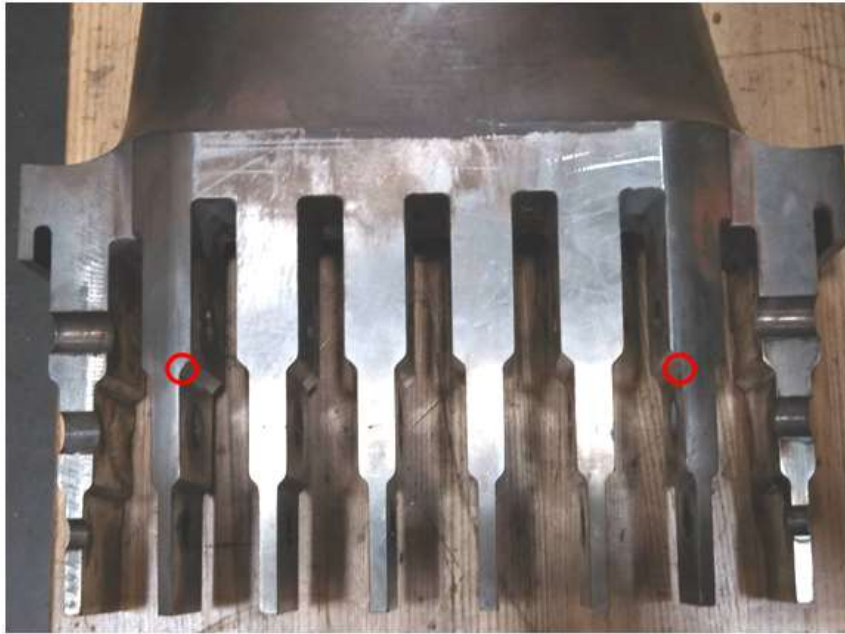
Tall LP blades are subjected to high centrifugal loads and water droplet erosion during operation. Specific to this fleet is cracking of the pin finger roots. The cracks occur at the corners or transition points on the fingers as shown in Figure 24.

Figure 24: L-0 Pin Finger Root Cracking Locations

This cracking is caused by low cycle fatigue, related to the number of unit starts and stops. This issue is common among the 1219 mm and 1067 mm tall L-0 blades even though the 1219 mm blade is made from titanium and the 1067 mm blade is made from M152. Titanium is highly notch sensitive and the stress concentration factor is therefore higher for a blade of the same geometry but different material. Both blades require the same improvements to the root.

In order to resolve the issue and provide owners with an alternate solution to the OEM's recommended replacement a development project was launched. The result is an option to modify in-service blades by means of a geometry modification as well as proprietary surface treatment which reduces cyclic stresses in these areas. The result of which is approximately a four times multiple of life for the 'recycled' blade option over OEM design. Figure 25 shows the end result of a recycled blade.

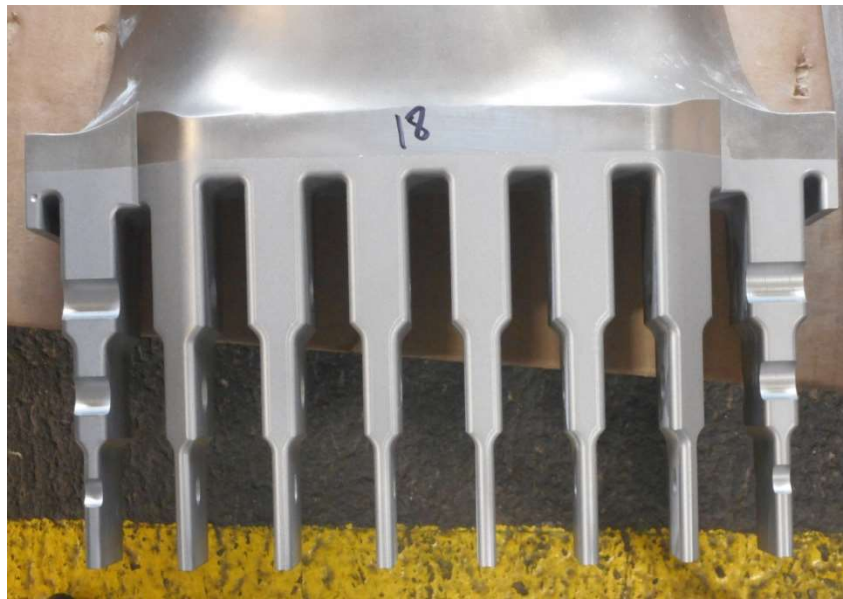
Figure 25: L-0 Pin Finger Root Modification

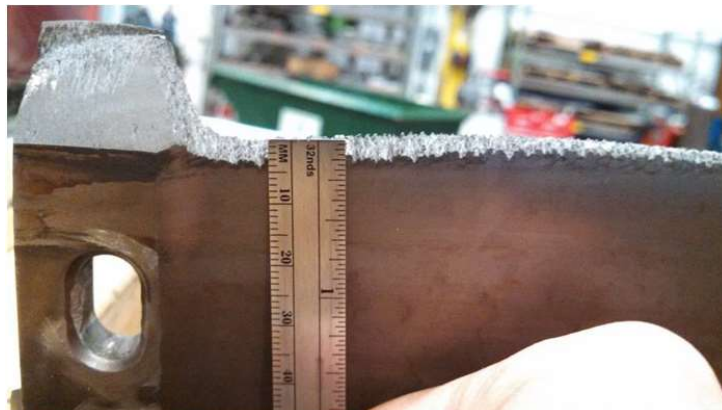
Figure 26: L-0 As found In-Service Blade

Also addressed is the erosion of the in-service blade with a repair that restores the blade to a like new condition as shown in Figures 26 and 27.

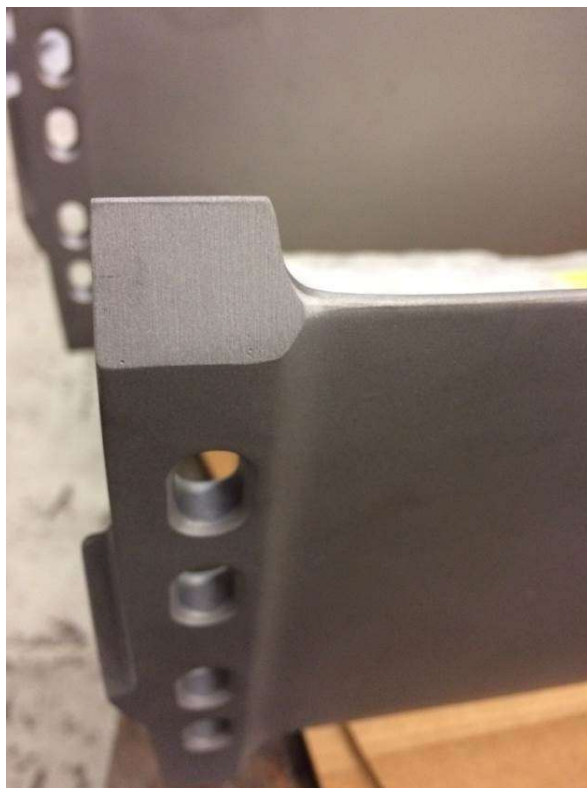
Figure 27: L-0 As Repaired In-Service Blade

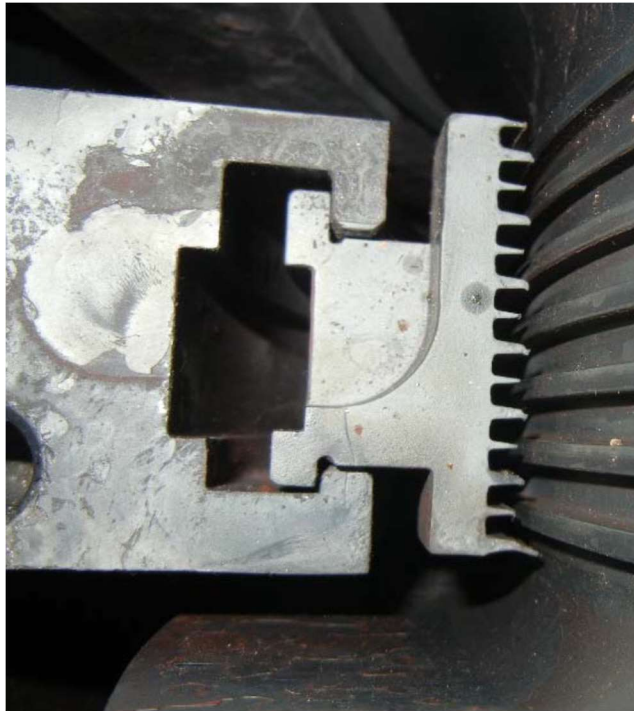
- Axial Seal Rubs as shown in Figure 28
 - N2 & N3 location occurrence – long rotor condition
 - Excessive leakage at higher loads limits turbine output
- Long Flexible HP rotor
 - Seal Wear
 - Rotor vibration from rubs
- Same LP blades as D-11 (34.5" M152 and 40" Titanium L-0)
- Difficult to set radial clearances and align
 - Tops-on alignment used by some customers

Figure 28: A-10 N2 Axial Seal Rub

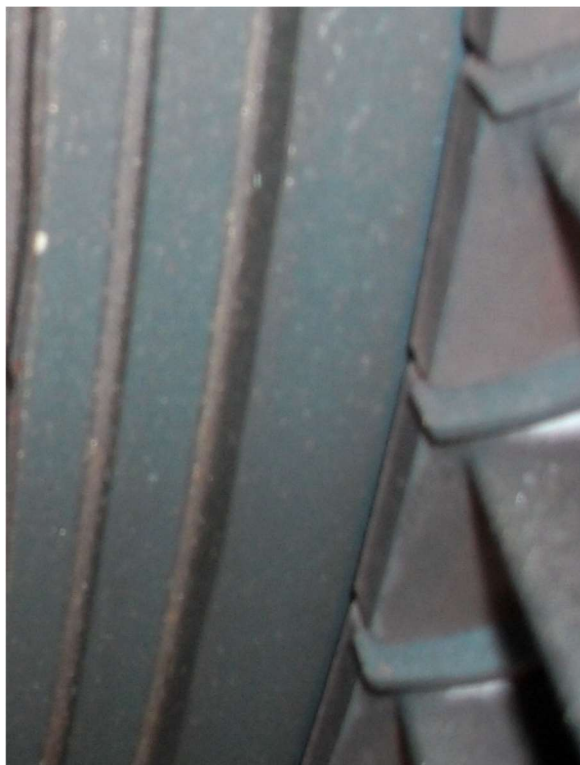
One of the issues with this fleet of combined cycle steam turbines is related to the blade-shim design for the HP and IP first stage rotating blades. Failures have occurred by way of shim migration/failure as shown in Figure 29, as well as cracks in the highly stressed area of the blade root fillet near the load carrying hook as shown in Figure 30.

Figure 29: HP/IP First Stage Blade Root Crack

A combination of underlying factors contribute to the cause of these failures such as thermal expansion coefficient differences between the blade and shim material, the installation of blades with a clearance at the blade root, thermal ratcheting as well as not having a locking blade/mechanism or entry slot.

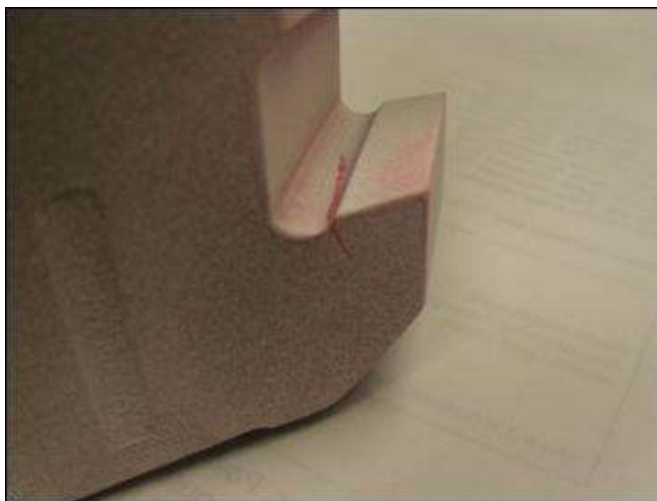
Figure 30: HP/IP First Stage Blade Root Crack

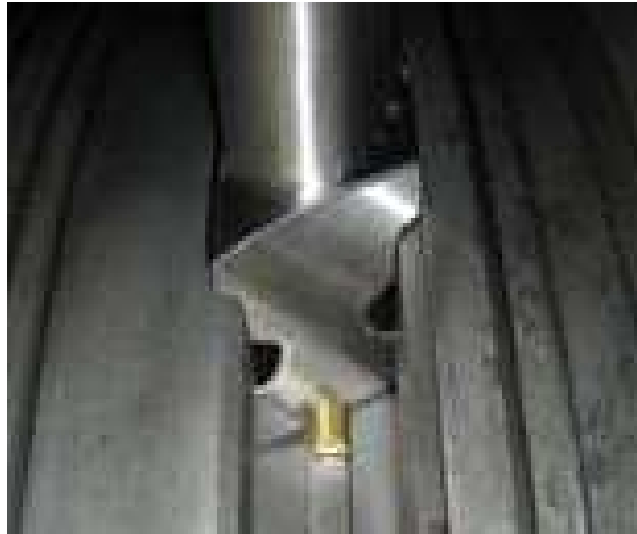
Figure 30: HP/IP First Stage Blade Root Crack

As an alternative to the OEM solution, a development program led to a redesign which has been installed in multiple units without issue. This new design addresses each of the underlying issues mentioned from a geometry change, material change, shim elimination and addition of an entrance slot. This solution is shown in Figure 30.
