17-IAGT-207

# PRACTICAL EXPERIENCE WITH FULL SOLUTION REJUVENATION OF SINGLE CRYSTAL GAS TURBINE BLADES

Justin Kuipers, P.Eng.

*Liburdi Turbine Services Inc*  
400 Highway 6 N, Dundas, ON, Canada  
([jkuipers@liburdi.com](mailto:jkuipers@liburdi.com))

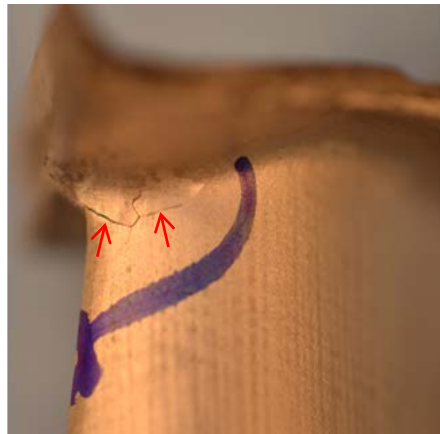
**Figure 1:** An example of a service run blade comprised of a single crystal alloy, exhibiting cracking along the grain boundary of stray grains in the airfoil to shroud radius (indicated by red arrows).

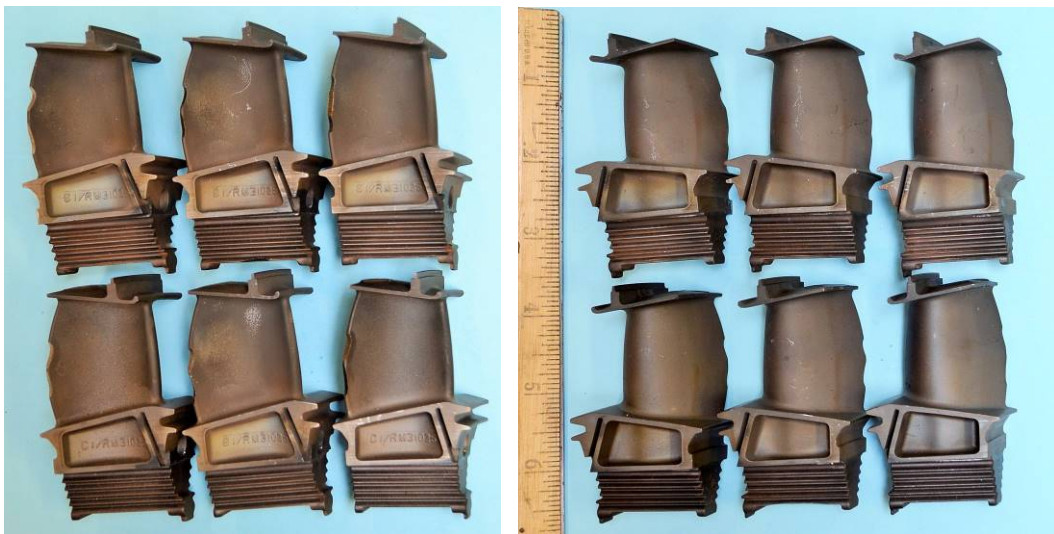
Six life expired Siemens SGT-100 HP turbine blades comprised of CMSX-4 single crystal alloy were used for demonstration repair and destructive analysis, **Figure 2**. The blades were reported to have operated for approximately 28,000 hours, following which they were repaired once and then operated for an additional approximately 12,000 hours (i.e. approximately 36,000 total service hours). At this point the blades were deemed to be life expired per the manufacturer's life limit for the component. The basis for the life limit (the life limiting damage mechanism) was unknown.

**Figure 2:** As received appearance of the blades used for repair demonstration (concave and convex side). Note that the blades had been 'notched' on the trailing edges identifying them as unserviceable.

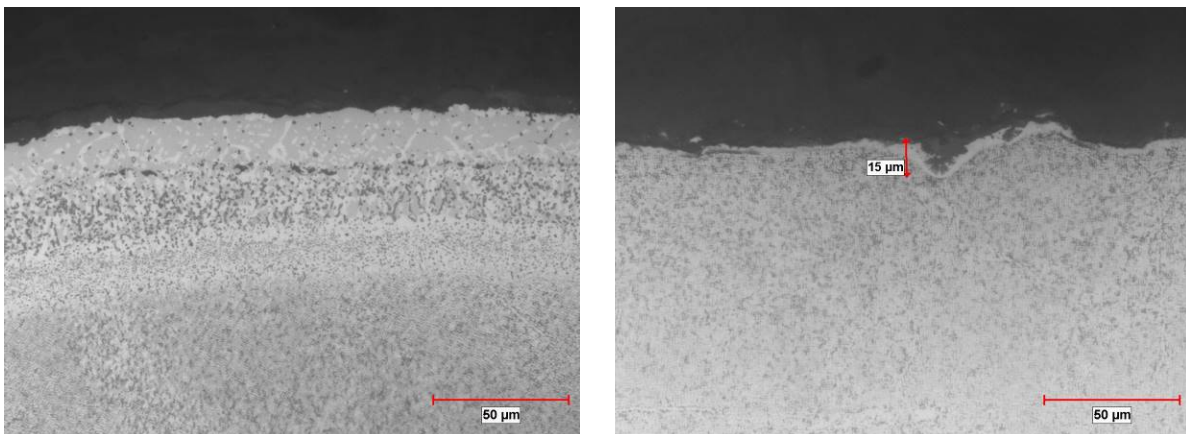
The external airfoil surfaces were coated with a platinum aluminide coating, **Figure 4 left**. The coating was partially consumed, however, it had provided effective protection for the prior service interval as no damage to the underlying base alloy was observed.

The internal airfoil surfaces were uncoated, **Figure 4 right**. Minor base alloy oxidation was observed on the internal surfaces, penetrating  $<25\mu\text{m}$  (0.001 inches) deep.

**Figure 4:** Micrographs of the post service, as received external (left) and internal (right) airfoil surface conditions.

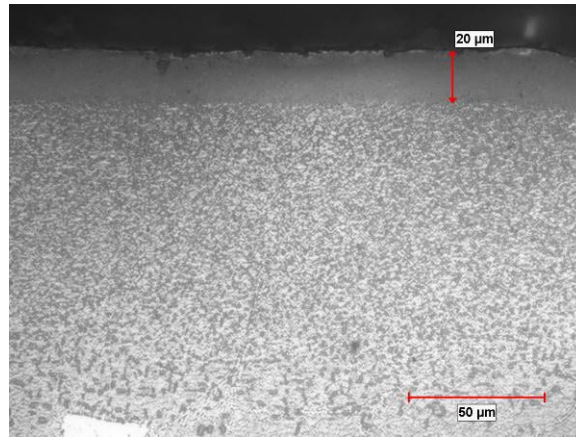
An alloy denuded layer  $20\mu\text{m}$  thick was observed on the surface of the root, **Figure 5**. The layer was considered likely to be a result of original manufacture and/or repair processing rather than service induced as no oxidation was evident on the surface. For example, it may have been due to a reaction with a processing material or atmosphere. No recrystallization was observed on the root surfaces.

**Figure 5:** Micrograph of the post service, as received root surface condition.

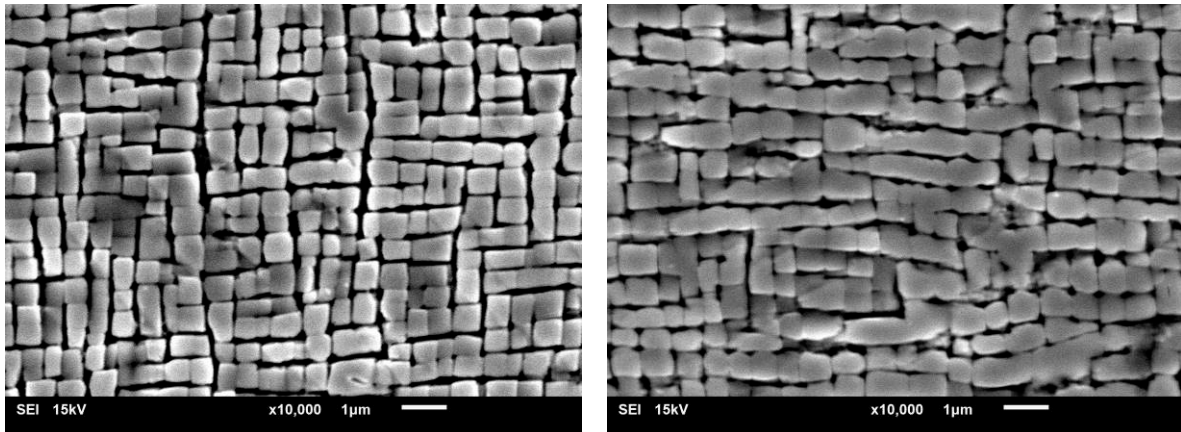
The  $\gamma'$  structure in the root is considered representative of the alloy's pre-service condition, as the root operates at temperatures below which observable microstructural degradation occurs. The  $\gamma'$  structure in the root was observed to be characteristic of fully heat treated CMSX-4 alloy, exhibiting a high density of cuboidal primary  $\gamma'$  precipitates with fine secondary  $\gamma'$  precipitates dispersed throughout, **Figure 6 left**. No appreciable aging (microstructural degradation) was observed at the examined airfoil locations in comparison to the root, **Figure 6 right**.

**Figure 6:** Micrographs of the post service, as received gamma prime morphology of the root (left) and mid to upper airfoil trailing edge (right).

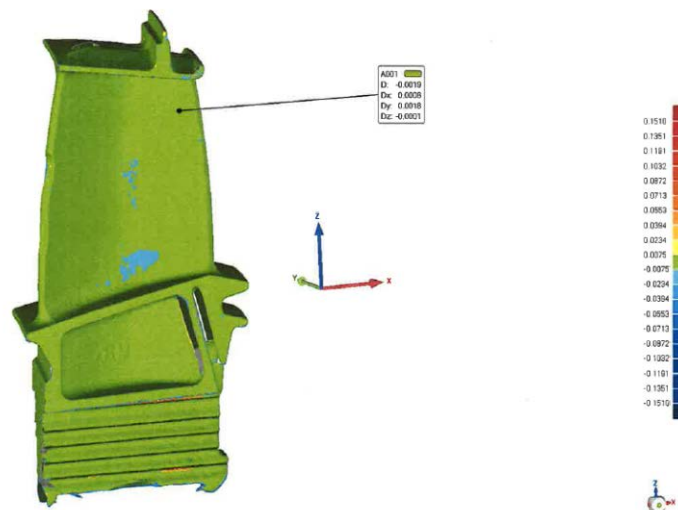
After removing the coating, 3 blades were scanned with a laser coordinate measuring machine (CMM). The same blades were re-scanned with the CMM following solution heat treatment, and a deviation analysis was produced which reveals any geometric change or distortion of the blade resulting from the heat treatment. No significant changes occurred as a result of the heat treatment, **Figure 7**.

**Figure 7:** Typical CMM deviation analysis of a blade showing no significant dimension change/distortion after solution heat treatment. Units: inches.

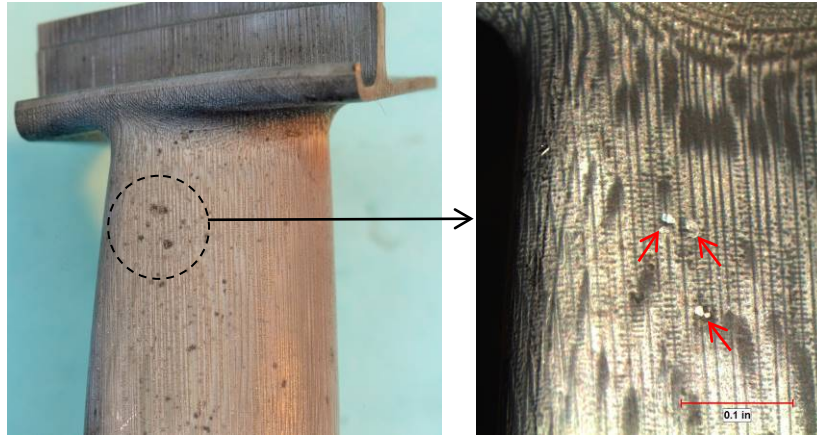
After rejuvenation processing including full solution heat treatment (above  $\gamma'$  solvus), the blades were non-destructively inspected for recrystallized grains in critical areas by chemical etching. Four out of the five blades were found to exhibit recrystallized grains in critical areas to varying extents, an example of which is shown in **Figures 8 and 9**. Destructive examination verified that the depth of recrystallization in the case of at least one blade was beyond serviceable limits (not all recrystallized areas were destructively examined).

**Figure 8:** Example of recrystallized grains (indicated by red arrows) on the airfoil after rejuvenation heat treatment processing and chemical etching. The grains appeared to have nucleated from minor service related impacts on the convex leading edge.

Based on this finding, an additional twelve life expired blades were submitted for further analysis – seven from the same blade set as the six originally tested blades and five from a different blade set. All blades were subject to repair which included coating removal and full solution heat treatment rejuvenation processing followed by macro etch inspection for recrystallized grains. All blades were found to initially exhibit some recrystallized grains in critical areas to varying extents. The blades were then put through a cycle of mechanically removing the grains and re-inspection

until the recrystallized grains had been eliminated from all critical areas. Finally, eight blades were destructively examined (five from the group of seven, and three from the group of five) to verify the inspection results and assess the remaining wall thickness. All seven blades from the first group were found to be within repair limits and four out five of the blades from the second group were found to be within repair limits.

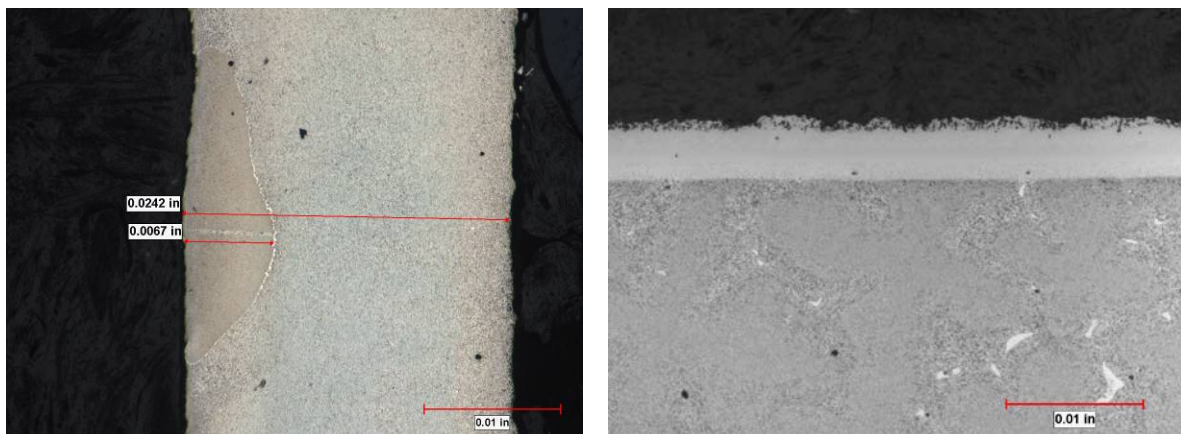
Two of five initial trial repair blades were recoated with a platinum aluminide coating. Both coated and uncoated blades from the initial group of five blades were destructively examined post repair. Recrystallized grains were observed at the upper airfoil leading edge external surface penetrating up to 170 $\mu$ m (0.0067 inches) deep on the uncoated blades, **Figure 9**. On the coated samples, all surfaces were found to be fully coated. The coating met the specified requirements for the application.

**Figure 9:** Micrographs of the external airfoil surface condition, post rejuvenation heat treatment. Recrystallized grains were observed in some cases (upper airfoil leading edge shown at left). On the coated samples, all surfaces were fully coated (right).

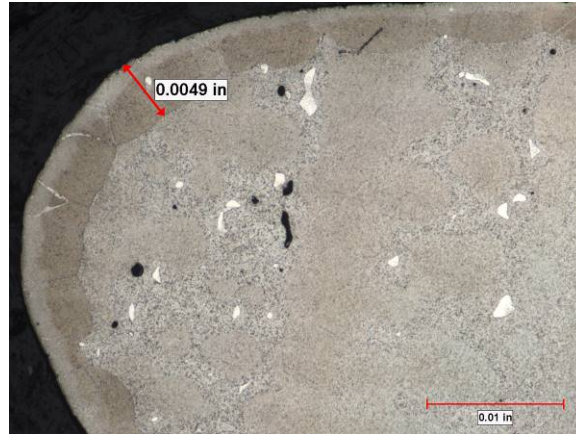
A relatively uniform layer of fine recrystallized grains penetrating up to approximately 125 $\mu$ m (0.005 inches) deep was observed on the root serrations of each of the destructively examined blades, **Figure 10**. The recrystallized layer indicates that the root surfaces had likely been peened at original manufacture.

**Figure 10:** Micrograph of the typical post rejuvenation repair root surface condition exhibiting a layer of recrystallized grains on the surface.

The full solution heat treatment also resulted in a recrystallized layer on the root surfaces of the repaired blades. This indicates that the root surfaces had been peened during original manufacture and/or prior repair. The depth of recrystallization on the roots was comparable to that of a previous study which found that recrystallization of root surfaces of single crystal blades was an acceptable condition for continued operation with post heat treatment processing [8].

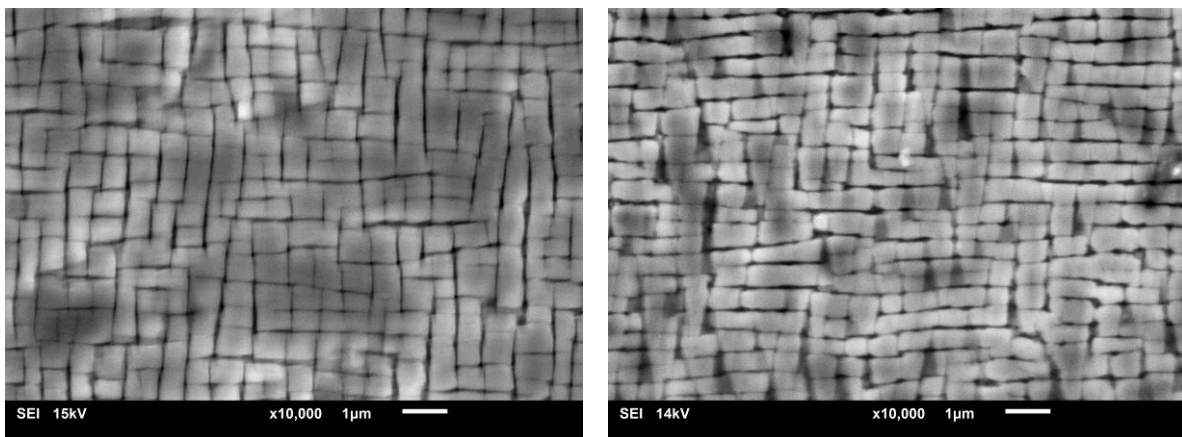
Following full solution (above  $\gamma'$  solvus) and ageing heat treatments, the  $\gamma'$  structure in the root and airfoil was observed to be typical of fully heat treated CMSX-4 alloy, comparable to the as manufactured root microstructure (refer to Figure 6 left), **Figure 11**.

**Figure 11:** Micrographs of the post rejuvenation repair gamma prime morphology of the root (left) and mid to upper airfoil trailing edge (right).

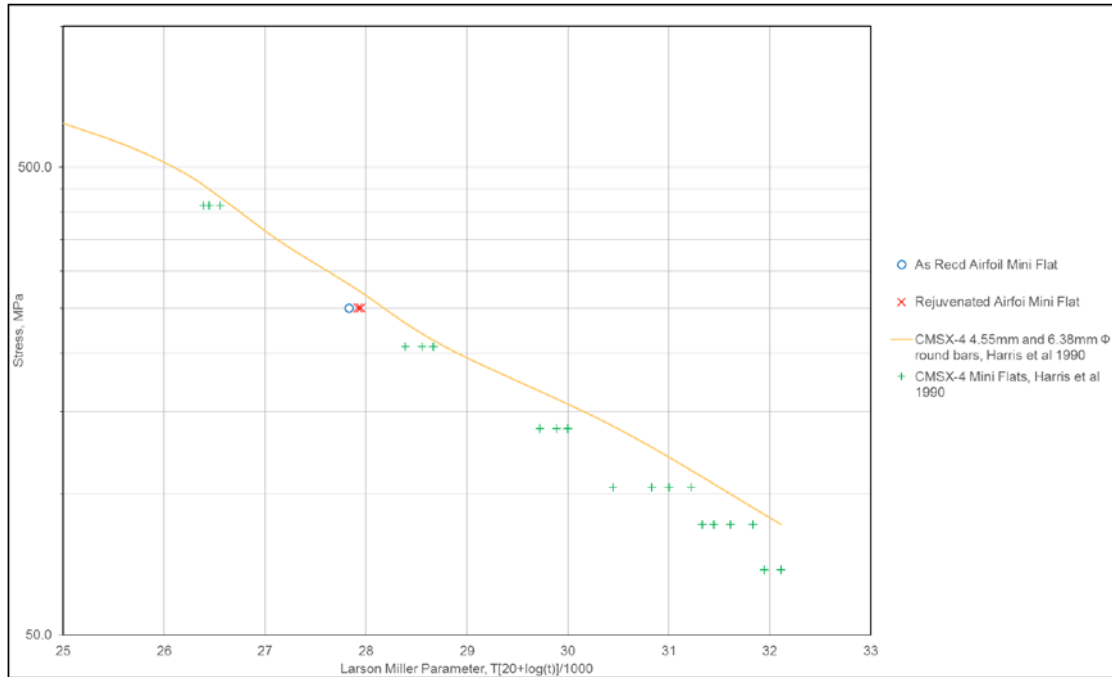
The as received and post rejuvenation stress rupture results are shown on a Larson Miller plot in comparison with fully heat treated CMSX-4 stress rupture data from literature [9], **Figure 11**.

**Figure 11:** Larson Miller plot comparing the as received and rejuvenated stress rupture results with data from literature for fully heat treated CMSX-4 [9].
