# Practical Experience With Full Solution Rejuvenation of Single Crystal Gas Turbine Blades

By  
Justin Kuipers / Liburdi Turbine Services Inc.

Presented at the 2017 Symposium on Industrial Application of Gas Turbines (IAGT)  
Banff, Alberta, Canada - October 2017

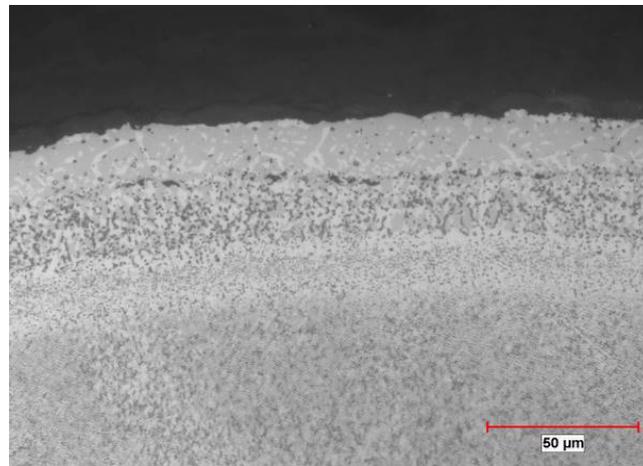
External airfoils surfaces platinum aluminide coated. Coating partially consumed, no base alloy damage.

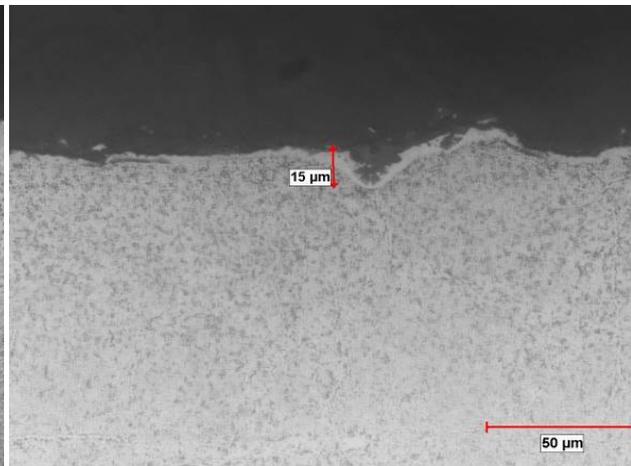
Internal airfoil surfaces uncoated. Minor base alloy oxidation <25μm (0.001 inches) deep.

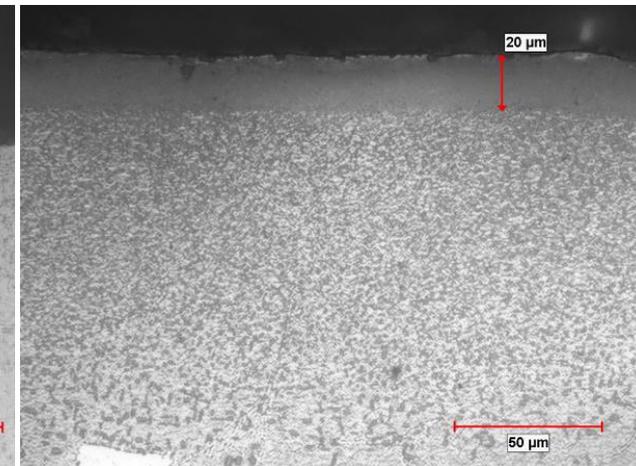
Root surfaces exhibited 20μm thick alloy denuded layer. No Rx on root surfaces.

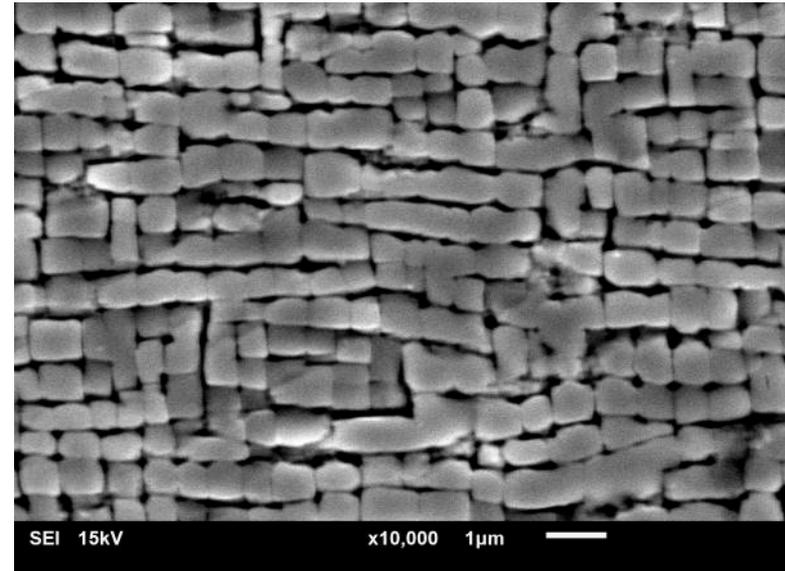
Mid airfoil trailing edge

Location	Life (hours)	Elongation (%)
Mid chord airfoil	82.8	30.6

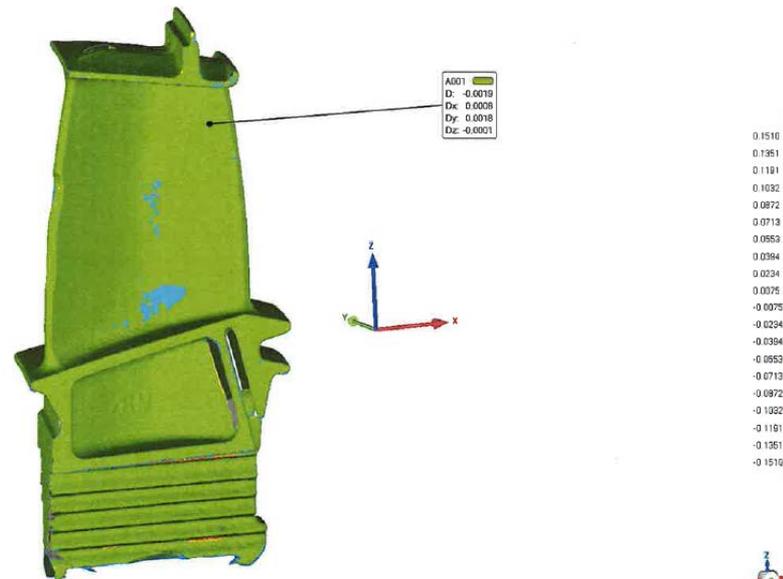
Typical pre and post heat treatment CMM deviation analysis showing no significant dimensional change

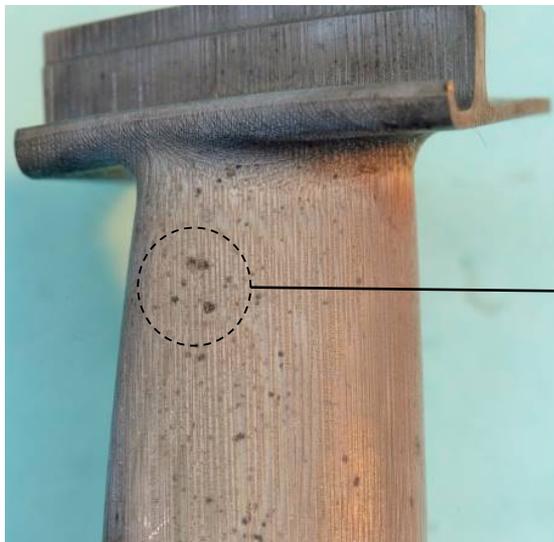
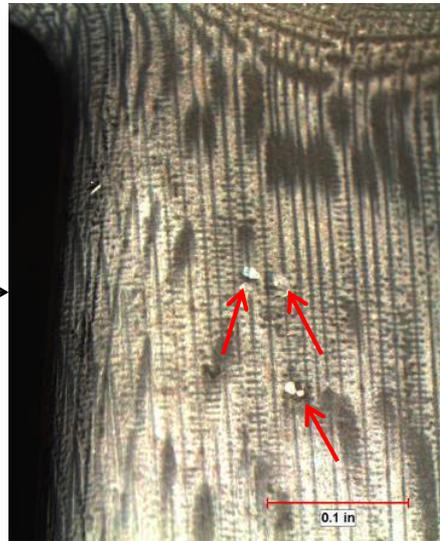
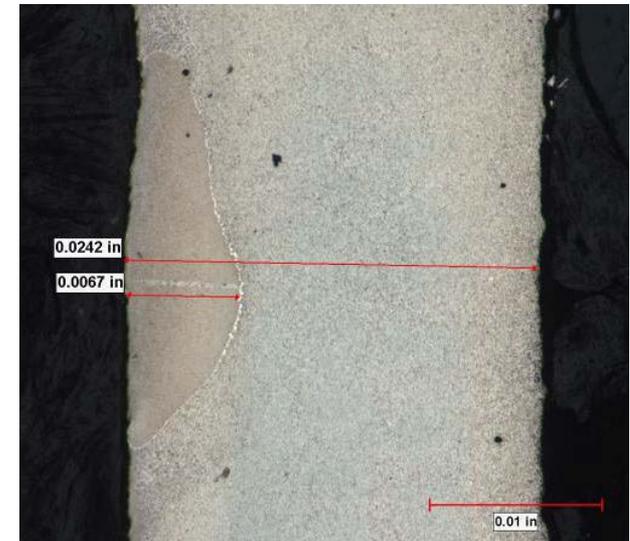
- After rejuvenation processing, the blades were inspected for recrystallized grains in critical areas by chemical etching
- 4 out of 5 blades were found to exhibit recrystallized grains in critical areas to varying extents
- Destructive examination verified that the depth of Rx in the case of at least one blade was beyond serviceable limits

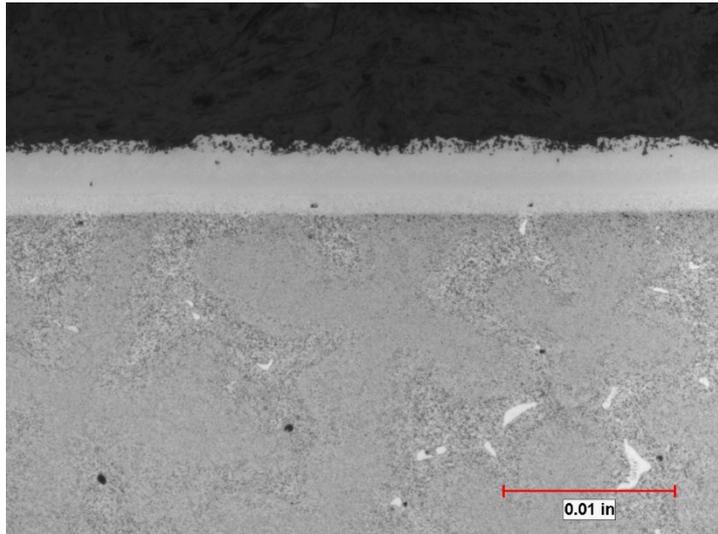
External airfoils surfaces  
all surfaces were found to  
be fully coated with  
platinum aluminide to  
specification.

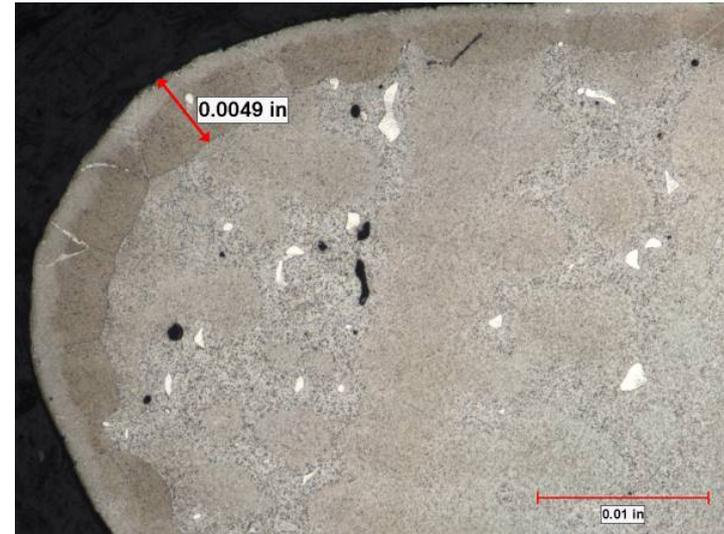
Root surfaces had uniform  
layer of recrystallized  
grains up to  $\sim 125\mu\text{m}$   
(0.005 inches) deep.

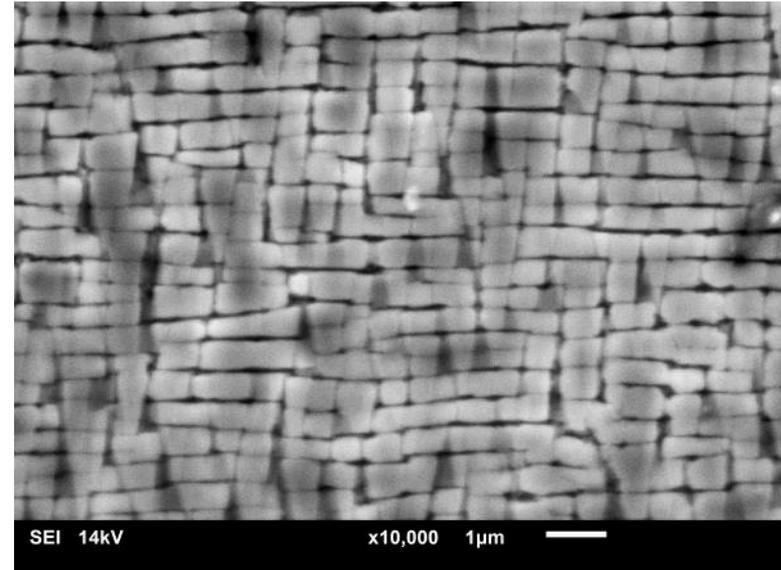
Mid airfoil trailing edge – post rejuvenation HT

Blade	Location	Life (hours)	Elongation (%)
1	Mid chord airfoil	102.2	37.1
2	Mid chord airfoil	96.9	28.0
