13-IAGT-XXX (REFERENCE PROGRAM)

AIRFOIL THICKNESS AS A LIFE LIMITING FACTOR OF GAS TURBINE BLADES

Kevin Wiens, P.Eng.*†

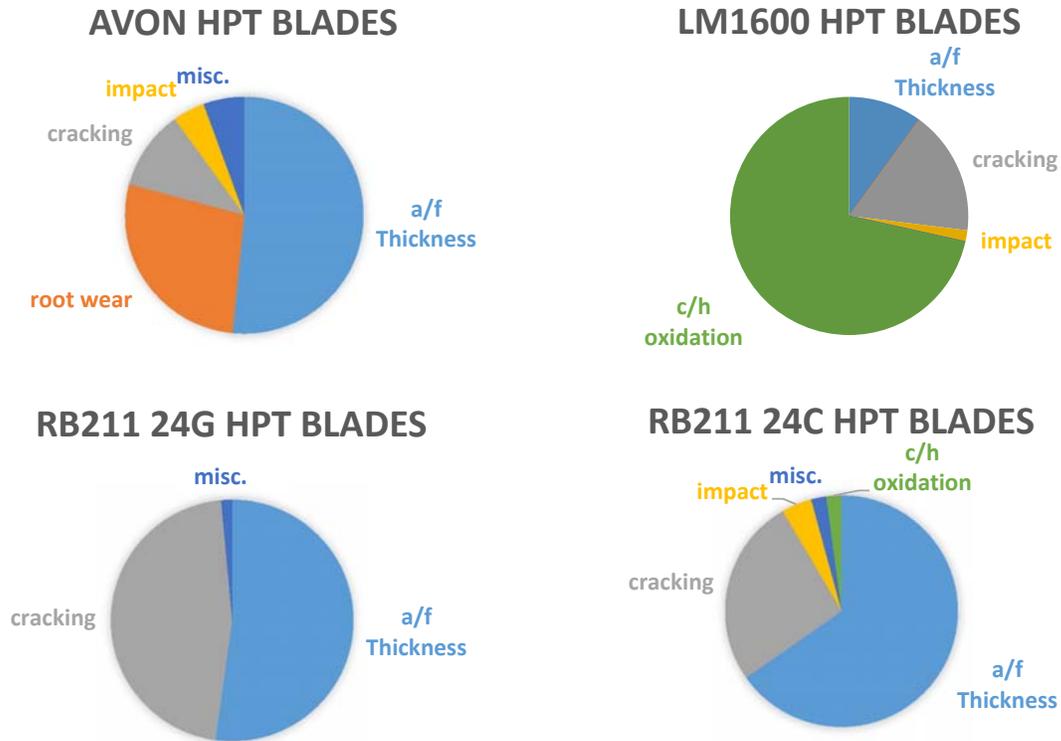
Figure 1 shows the causes for retirement for four types of aero-derivative first stage turbine blades, all of which received rejuvenation heat treatments during prior repairs. The data was collected from 90 sets of turbine blades (7260 individual blades). While the prevalence of the retirement causes varied for each type of blade, airfoil thickness was found to be the most dominant cause¹ overall.

Figure 1: Retirement causes for 4 types of gas turbine blades. The blades had been life extended by rejuvenation heat treatments.

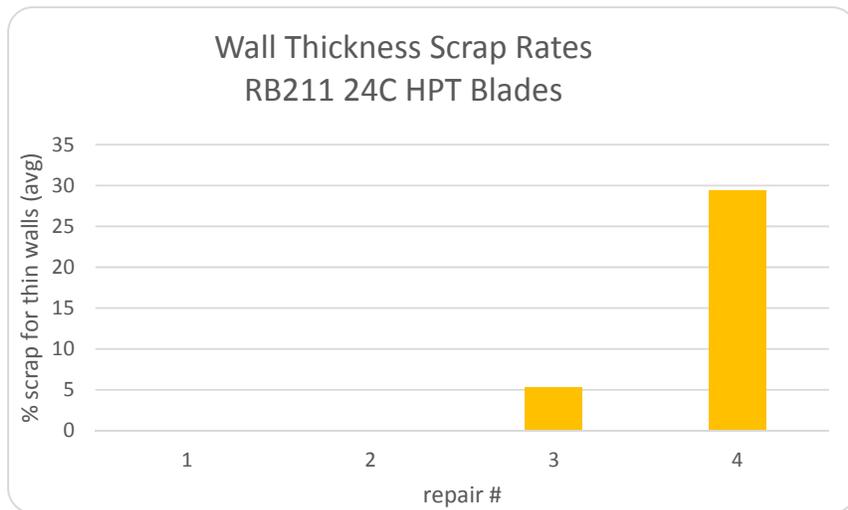
With each repair of gas turbine blades, wall thickness diminishes as coatings are stripped and oxidation damage is removed. **Figure 2** shows the increase in average scrap rate after each repair cycle for RB211 24C HPT blades. The number of blades scrapped for insufficient wall thickness after 2 repairs is typically negligible.

Figure 2: Scrap rates due to thin walls as a function of time (repair cycles) for RB211 24C HPT blades.

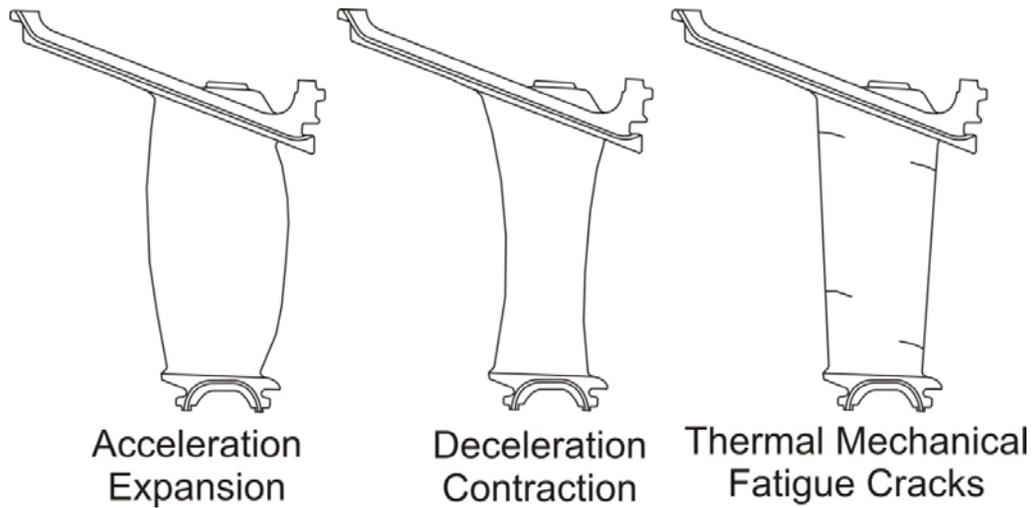
Even in cases where the *steady-state* stresses on the hot outer walls of a turbine blade airfoil are relatively low, thin walls may be subject to damage related to thermal cycling (*transient* stresses). Engine start-up and shut-down results in heat-up and cool-down rates which are dependent on the local thickness of the component. For example, the relatively thin trailing edges will expand and contract at a faster rate than the core of the airfoil [3, 4]. For vanes, this effect is exacerbated by the physical constraint of the outer shrouds, while rotating blades are relatively more free to expand radially. **Figure 3** depicts how thermal cycles result in thermal mechanical fatigue (TMF) cracking of the trailing edge airfoil of a turbine vane.

Figure 3: Mechanism for thermal mechanical fatigue of turbine vanes.

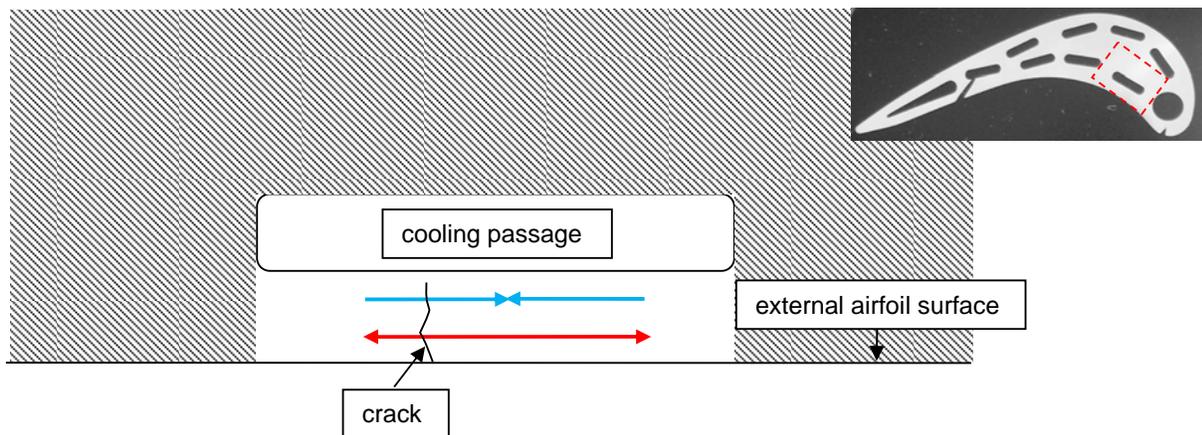
A mechanism for the observed cracking is depicted in **Figure 6**. On heating, the thin wall between the external surface and the cooling passage expands. The relatively bulky regions near the thin wall take longer to heat, constraining the thin wall leading to a compressive stress. Following shut down of the engine, the thin wall cools more rapidly than the surrounding metal, which generates a tensile stress perpendicular to the observed crack.

Figure 6: Schematic showing the mechanism for thin wall cracking during transient thermal loading. The thin wall expands (red arrow) and contracts (blue arrow) faster than the surrounding metal (hatched area) which generates stress cycles perpendicular to the observed crack.
