STEAM TURBINES IN COMBINED CYCLE : RELIABILITY & PERFORMANCE IMPROVEMENT SOLUTIONS IAGT 2017

David Archambeault*†

EthosEnergy

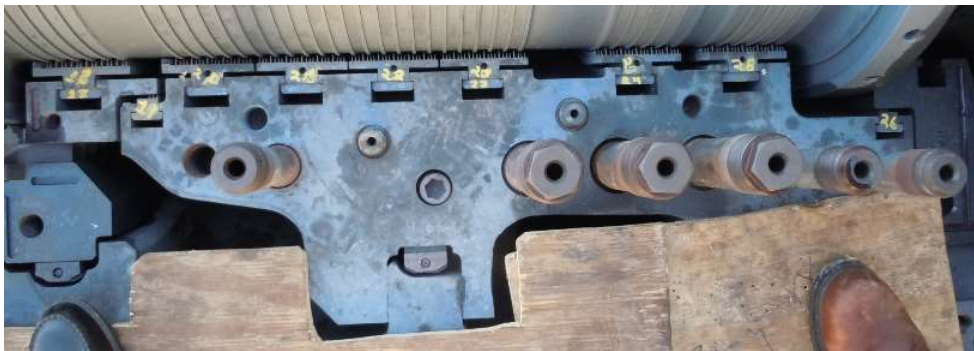
Figure 1: N2 Packing Casing

Problems with the N2 packing casing (shown in Figure 1) located near the midspan of the HP / IP rotor include joint leakage and ledge cracking. Since the rotor must be removed in order to perform necessary N2 repairs, the potential exists for these repairs to cause an extended outage. For example, if the cracks are severe and cannot be machined out, but need to be weld repaired. Given the combination of the issues with the N2 box owners/operators may elect to pre-purchase a spare N2 casing to have on-hand in order to mitigate risk.

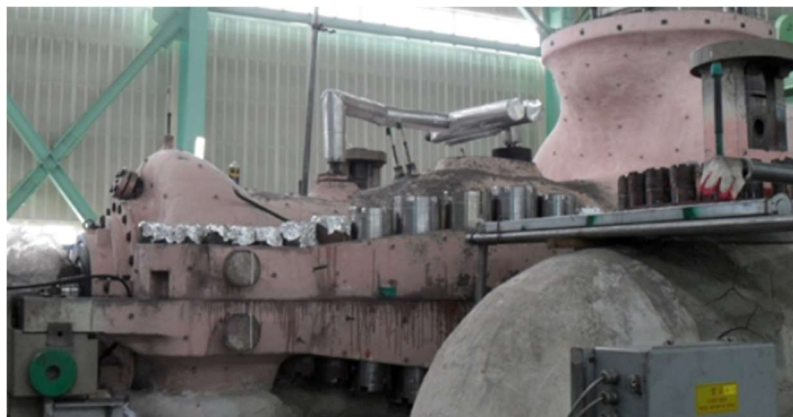
Figure 7: D-11 HP Shell

Similar in nature to the N2 packing casing leakage is the HP shell (shown in Figure 7) leakage. As in the case of the N2 box, the HP shell also exhibits leakage area as shown in Figure 8.

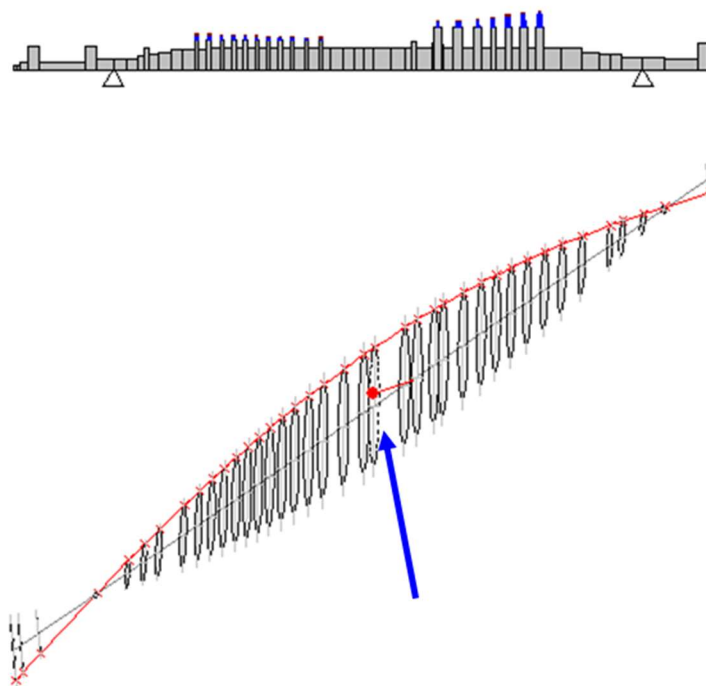
Figure 16: HP/IP Peak Rotor Displacement Orbit

Resulting from these seal rubs and a combination of other factors is rotor vibration. The HP/IP rotor in the D-11 is very flexible and is sensitive to midspan rubs. Further analysis indicates an amplification factor of over 24 as shown in Figure 15. Rotor trip on high vibration is 7.5 mils peak to peak, with a max displacement at seal location of .156 mils peak to peak as shown in Figure 16. Therefore, with a radial displacement of 78 mils, subtracting the operating clearance any casing distortion reduces the effective seal clearance.

In order to avoid a rub and subsequent wear during startup, while the rotor passes through first critical speed and peak displacement, a seal development is provided as an

option to owners/operators. These retractable seals have additional clearance during startup and shutdown as shown in Figure 17.

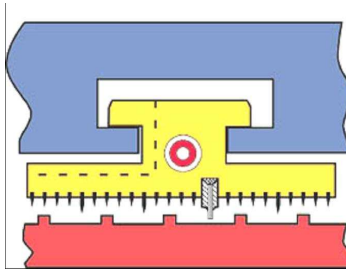
Figure 18: Seal in Operational State

Once full speed is reached and load is applied, the seal retracts as shown in Figure 18.

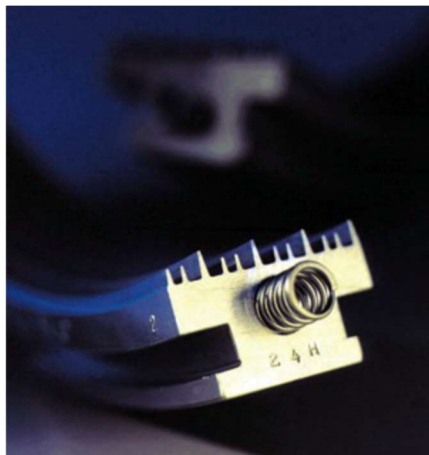
Figure 19: Retractable Seal Segment

Figure 19 shows a typical spring segment which provides the force necessary to maintain the seal open until sufficient pressure drop across the seal forces it closed. The design of this spring ensures closure takes place at load. Figure 20 shows a similar spring segment which also incorporates a compliant brush seal for added efficiency.

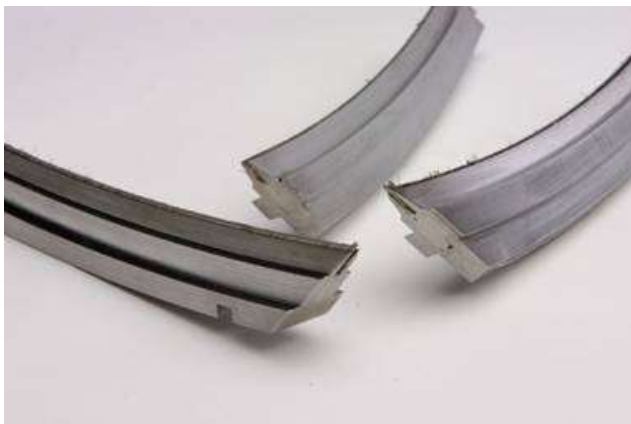
Figure 21: Tip Seal Segments

Similar in nature to the interstage and gland seals, are the tip seals used to seal the areas over the rotating blade shrouds as shown in Figures 21 to 23. Usage of these seals minimizes tip clearance and reduces leakage over previous designs.
