# Practical Experience With Full Solution Rejuvenation of Single Crystal Gas Turbine Blades

By  
Justin Kuipers / Liburdi Turbine Services Inc.

Presented at the 2017 Symposium on Industrial Application of Gas Turbines (IAGT)  
Banff, Alberta, Canada - October 2017

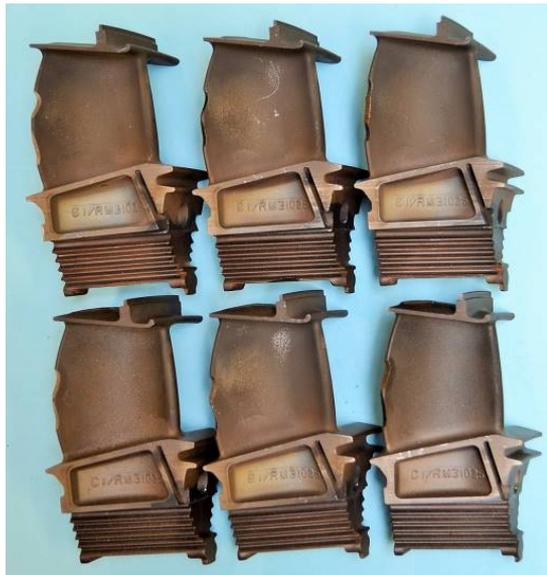
SGT-100 HPT Blades

- Life expired SGT-100 HPT blades, CMSX-4 alloy
- 28,000hrs → repair → 12,000hrs → life expired per OEM limit
- 1 blade examined in service run, as received condition
- Trial repair on 5 blades including: removal of the coating, dimensional and penetrant inspection, rejuvenation heat treatment, Rx grain inspection, platinum aluminide coating.

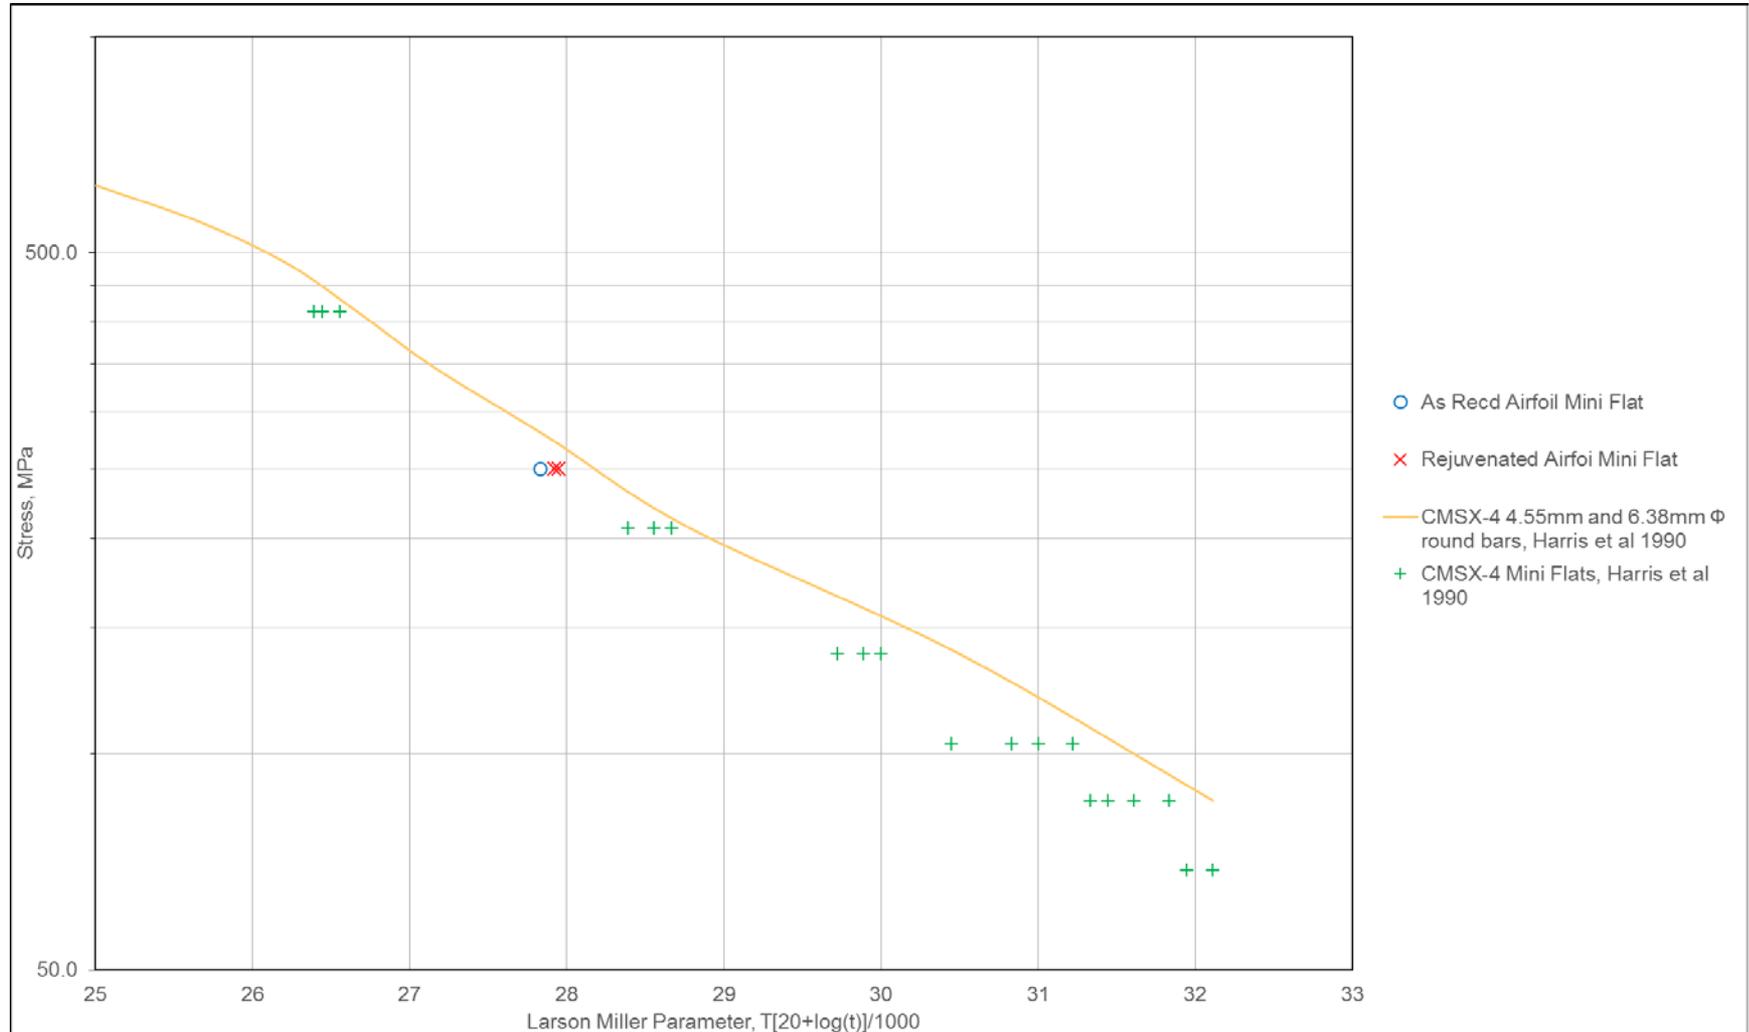
# Repair Trials Stress Rupture Testing

Post Rejuvenation Stress Rupture Test Result (997°C, 250 MPa)

Blade	Location	Life (hours)	Elongation (%)
1	Mid chord airfoil	102.2	37.1
2	Mid chord airfoil	96.9	28.0
